Town of Arlington, Massachusetts

PART A – Executive Summary Self- Evaluation and Transition Plan

November 2019

Part A – Executive Summary

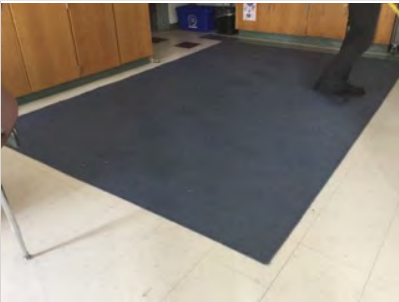
Surface not stable, firm, and slip-resistant	-	Securely attach all the mats in the room.	4	Labor	\$0
Access to Goods and Services												
87	Classroom	2	218A	Doors, Doorways, & Gates	Classroom

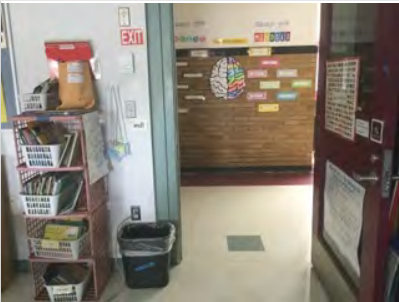
Maneuvering clearance(s) not provided	-	Relocate trash bin to ensure there is 18" clear on the latch pull side of the door.	1	Labor	\$0

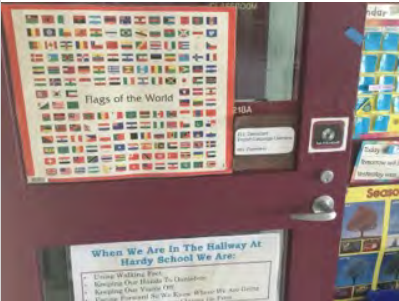
88	Classroom	2	218A	Signage	Designation

Raised characters not provided Braille not provided	- -	Provide text with raised characters duplicated in braille.	1	116	\$116

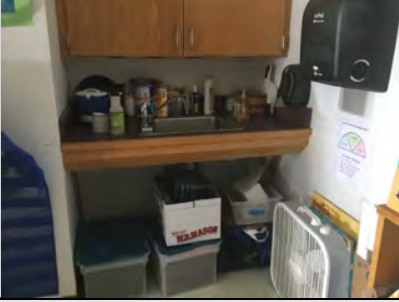
ID	Location	Floor	Room	Element	Type	Photo	Issues	Current Measure	Recommendations	Quantity	Price	Cost Estimation
89	Classroom	2	218A	Interior Access Route	N/A

Obstructed by protruding objects Not operable with a closed fist	10"	Relocate paper towel dispenser out of the circulation path. Provide a paper towel dispenser that can be operable with a closed fist.	1	628	\$628
Additional Access												
90	Classroom	2	218A	Sink	Classroom

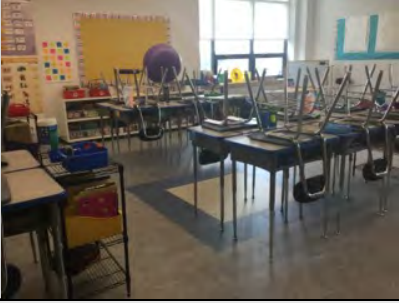
At least one or 5% accessible tables not provided Knee or toe clearance not provided	- 22" wide	Provide at least 1 work surface with 24" min. high, 30" min. wide knee and toe clearance.	1	350	\$350

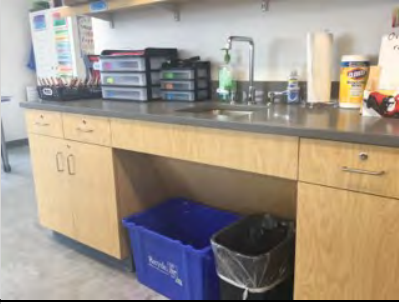
Additional Access												
92	Second Grade Classroom	2	221	Sink	Classroom

Toe and knee clearances not provided	-	Ensure there is knee clearance positioned for a forward approach by relocating the recycling bin and trash bin. 18" deep at the sink is not entirely compliant, but usable.	1	Labor	\$0
93	Second Grade Classroom	2	221	Storage	N/A

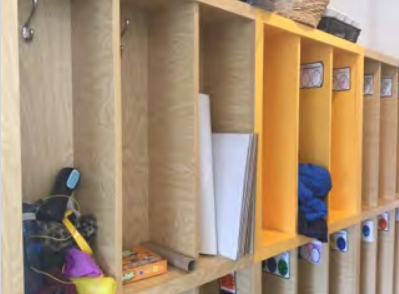
Storage operable parts > 48" high At least one accessible storage unit not provided	- 72"	Storage compartments are either located higher than 54" or lower than 15" to the ground. Provide one storage compartment min. that is located between 15" and 48" above the finished floor. Best Practice: Relocate at least one storage areas to be between 18" and 40" above the finished floor (for children's reach ranges).	1	378	\$378

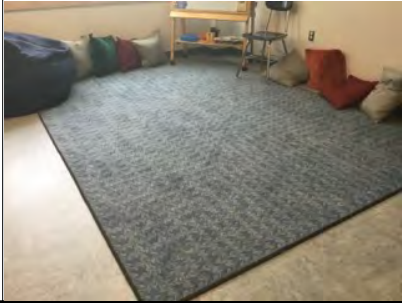
ID	Location	Floor	Room	Element	Type	Photo	Issues	Current Measure	Recommendations	Quantity	Price	Cost Estimation
Access to Goods and Services												
94	Second Grade Classrooms	2	221 222	Interior Access Route	N/A

Surface not stable, firm, and slip-resistant	-	Securely attach mat.	2	Labor	\$0
Access to Goods and Services												
95	Second Grade Classroom	2	222	Dining or Work Surfaces	Work Surface

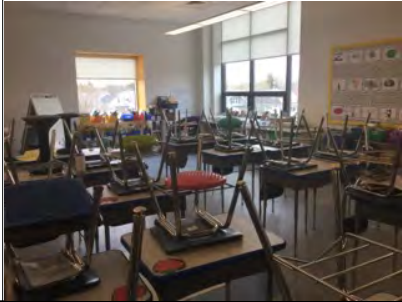
At least one or 5% accessible tables not provided Knee or toe clearance not provided	- 22" wide	Provide at least 1 work surface with 24" min. high, 30" min. wide knee and toe clearance.	1	350	\$350
Additional Access												
96	Second Grade Classroom	2	222	Sink	Classroom

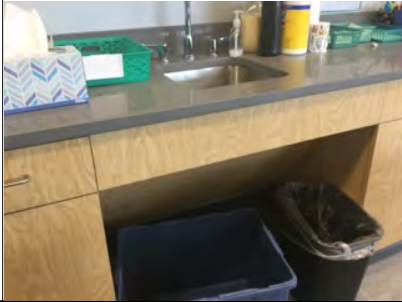
Toe and knee clearances not provided	-	Ensure there is knee clearance positioned for a forward approach by relocating the recycling bin and trash bin. 18" deep at the sink is not entirely compliant, but usable.	1	Labor	\$0

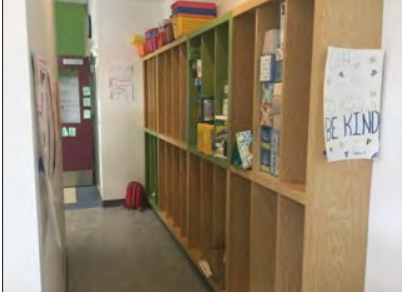
97	Second Grade Classroom	2	222	Storage	N/A

At least one accessible storage unit not provided Storage operable parts > 48" high	- 72"	Storage compartments are either located higher than 54" or lower than 15" to the ground. Provide one storage compartment min. that is located between 15" and 48" above the finished floor. Best Practice: Relocate at least one storage areas to be between 18" and 40" above the finished floor (for children's reach ranges).	1	378	\$378

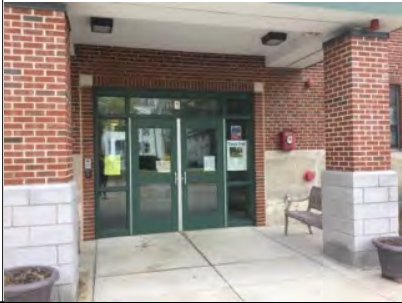
Maneuvering clearance at door > 1:50 (2.00%)	-	Provide an automatic door opener at the entrance door. Surface at entrance door is sloped greater than 2.00% Note: On March 22, 2018; The Massachusetts Office of Public Safety and Inspections Architectural Access Board granted relief until Feb. 2021 on the condition that status reports are provided to the board on January 1, 2019 and every six months thereafter.	1	1530	\$1530

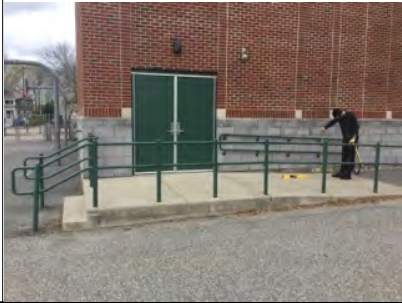
Access to Goods and Services												
100	Exit 12, South Side of School	Ext.		Ramps	Exterior

Edge protection < 4" high	-	Provide edge protection that prevents the passage of a 4" diameter sphere, where any portion of the sphere is within 4" of the finished floor or ground surface.	1	1260	\$1260
Best Practice												
101	Exit 2	Ext.

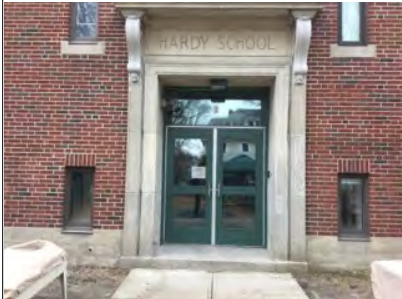
-	Best Practice: Although not understood to be an entrance by either of the two ADA surveys as an entrance, the public may mistake it for one due to the stonework with the schools name carved on it. Consider providing a directional sign to the nearest accessible entrance.	1	-	\$0

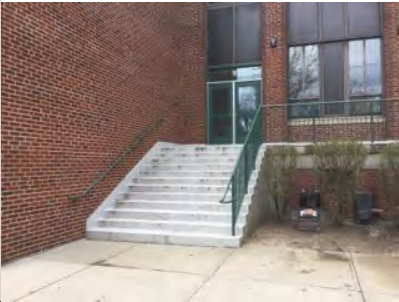
ID	Location	Floor	Room	Element	Type	Photo	Issues	Current Measure	Recommendations	Quantity	Price	Cost Estimation
Access to Goods and Services												
102	Exit 4	Ext.		Means of Egress	N/A

Tactile exit sign not provided Directional sign to accessible emergency exit not provided	-	Provide a directional sign indicating the location of the nearest emergency exit on the interior of the door. Provide a tactile exit sign with raised characters and braille at exit doors. Mount signs between 48"- 60" above finished floor located on the latch side of the door on the interior.	2	116	\$232
Access to Goods and Services												
103	Exit 5	Ext.		Means of Egress	N/A

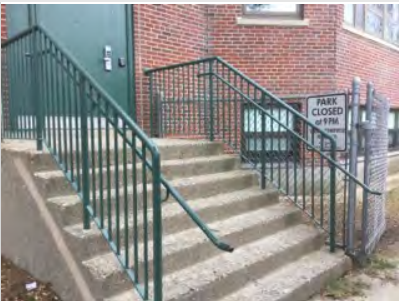
Tactile exit sign not provided Directional sign to accessible emergency exit not provided	- -	Provide a directional sign indicating the location of the nearest emergency exit on the interior of the door. Provide a tactile exit sign with raised characters and braille at exit doors. Mount signs between 48"- 60" above finished floor located on the latch side of the door on the interior.	2	116	\$232

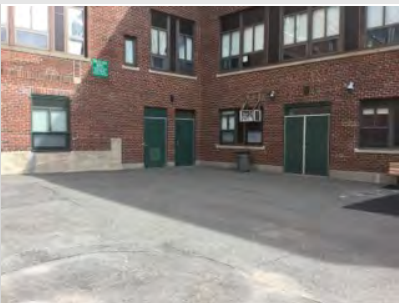
Access to Goods and Services												
104	Exits 8 and 6	Ext.		Means of Egress	N/A

Illuminated exit sign with International Symbol of Acc. not provided Tactile exit sign not provided	- -	On the interior of accessible exits provide an illuminated sign with the International Symbol of Accessibility (ISA). On the interior of exits, provide a tactile exit sign with raised characters and braille at exit door. Mount signs between 48"- 60" above finished floor located on the latch side of the door.	4	116	\$464
Approach and Entrance												
105	Parking Lot	Ext.		Off-Street Parking Lot or Garage	Visitor

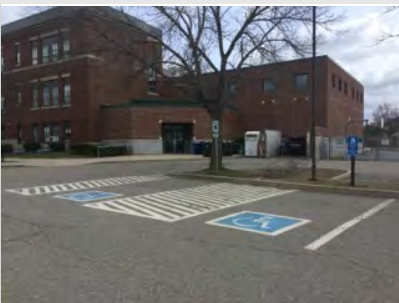
Total # of parking Total # of designated accessible parking spaces Total # of designated van accessible spaces Sign does not have the designation "Van Accessible" Sign bottom < 60" above finished grade	34 1 1 - 37.25"	Add the designation "Van Accessible" to the sign located at the van accessible space. Locate sign with the bottom of the sign 60" above the ground.	1	250 Labor	\$250

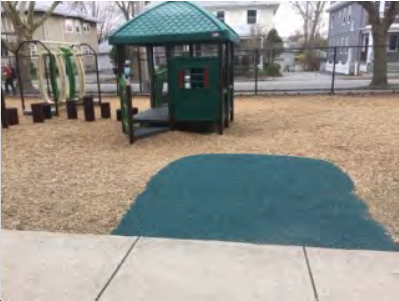
ID	Location	Floor	Room	Element	Type	Photo	Issues	Current Measure	Recommendations	Quantity	Price	Cost Estimation
Play and Sport Areas												
106	Playground on North Side of Building	Ext.		Play Areas	N/A

Accessible route not provided to play components	-	Provide a 5' wide accessible route to each play component. (Cost estimate for a 5' wide 30' poured-in-place rubber route to each play component.)	1	2100	\$2100
107	Playground on North Side of Building	Ext.		Play Areas	N/A

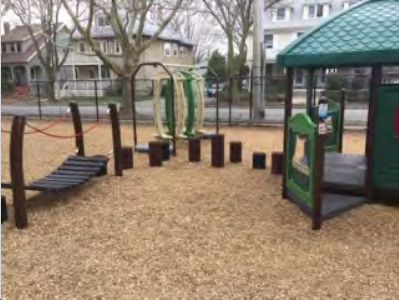
Accessible route not provided around the playground	-	Provide a 4' wide accessible route around the playground on the Lake Street side by the fence. (Cost estimate for a 4' wide 200' long asphalt route around the playground.)	1	6800	\$6800
108	Playground on North Side of Building	Ext.		Play Areas	N/A

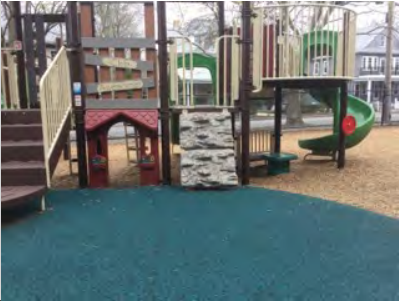
Accessible route not provided to play components		Provide a 5' wide accessible route to each play component. A route is only provided to part of the play component including the transfer platform. (Cost estimate for a 5' wide 36' poured-in-place rubber route to each play component.)	1	2520	\$2520

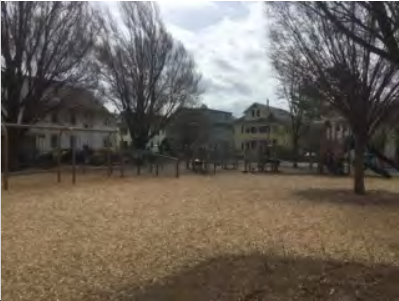
Play and Sport Areas												
109	Playground on South Side of Building	Ext.		Play Areas	N/A

Accessible route not provided around the playground Accessible route not provided to play components	- -	Provide a 4' wide accessible route around the playground. Provide a 5' wide accessible route to each play component. (Cost estimate for a 4' wide 265' long asphalt route around the playground and a 5' wide 648' poured-in-place rubber route to each play component.)	1	54370	\$54370
Approach and Entrance												
110	Route From Parking Lot to Main Entrance	Ext.		Curb Ramp	N/A

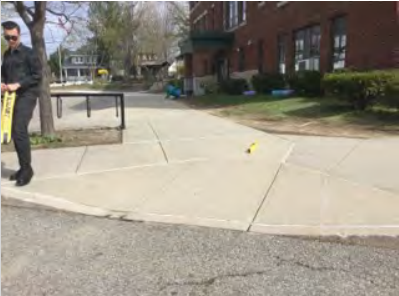
Landing not provided at top of curb ramp	7.6%	Provide landing at top of curb ramp or reconfigure ramp. Note: On March 22, 2018; The Massachusetts Office of Public Safety and Inspections Architectural Access Board granted relief until Feb. 2021 on the condition that status reports are provided to the board on January 1, 2019 and every six months thereafter.	1	2800	\$2800

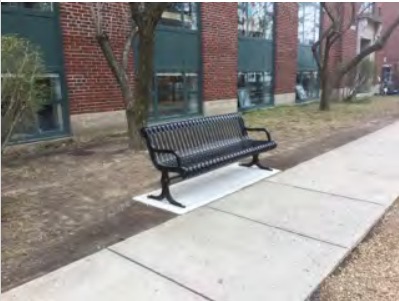
ID	Location	Floor	Room	Element	Type	Photo	Issues	Current Measure	Recommendations	Quantity	Price	Cost Estimation
Best Practice												
111	Walkway Near Exit 2	Ext.

-	Best Practice: Provide clear floor space of 36" wide min. by 48" deep min. alongside at least one bench by Exit 2.	1	-	\$0
Access to Goods and Services												
112	Exit 13	G		Means of Egress	N/A

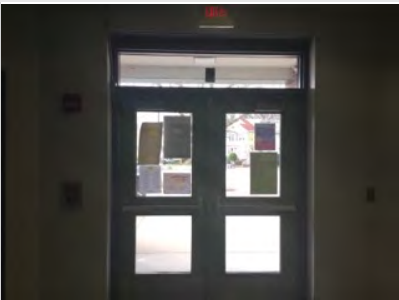
Tactile exit sign not provided	-	Provide a tactile exit sign with raised characters and braille at exit doors. Mount signs between 48"- 60" above finished floor located on the latch side of the door.	1	116	\$116
Additional Access												
113	Corridor by Girls' Toilet Room	G	G01	Drinking Fountains	Hi-Lo

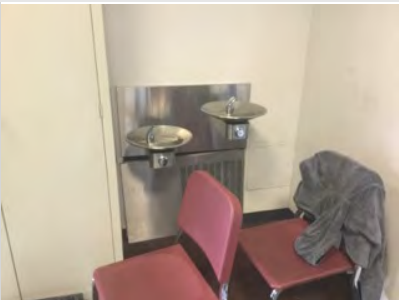
Clear floor space not provided	-	Ensure chairs are removed and no other items obstruct around the drinking fountain to provide a 30" by 48" clear floor space positioned for a forward approach.	1	Labor	\$0
Access to Goods and Services

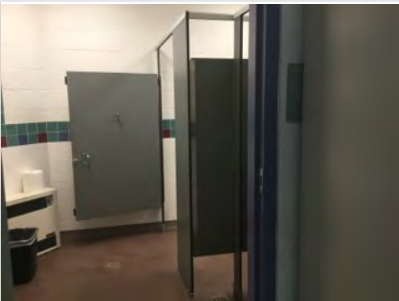
114	Girls' Toilet Room Near Gym	G	G01/ G10	Signage	Designation

Sign not located on the latch side of the door	-	Locate sign at permanent rooms alongside the door on the latch side. Ensure that sign is not obstructed or covered.	1	Labor	\$0

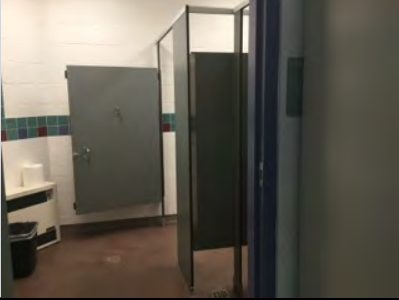
Maneuvering clearance(s) not provided	- -	Remove the wall cabinet alongside the door on the latch pull side to ensure that there is 18" clear alongside the door minimum.	1	Labor	\$0
Toilet Rooms for Children												
116	Girls' Toilet Room Near Gym	G	G01/ G10	Toilet Compartment	Accessible Compartment

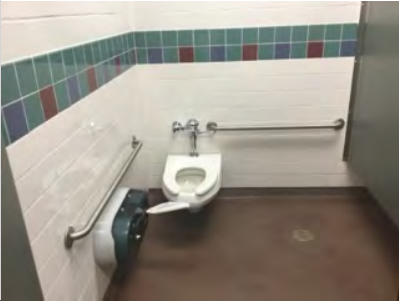
Door with malfunctioning self-closing hinge Non-compliant toilet paper dispenser	- -	Repair self-closing hinge. Replace toilet paper dispenser as it does not allow continuous paper flow.	1	Labor 353	\$353
Access to Goods and Services												
117	Boys' Toilet Room Near Gym	G	G02 / G11	Signage	Designation

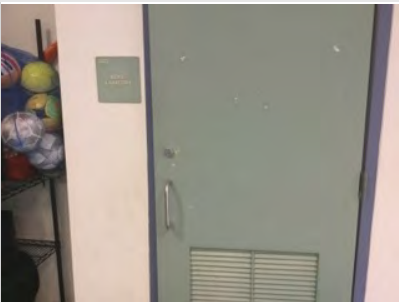
Non glare finish and contrast not provided International Symbol of Acc. not compliant	- -	Provide signs with a non-glare finish with characters that have a high contrast to the background. Replace sign with a sign containing the International Symbol of Accessibility.	1	116	\$116

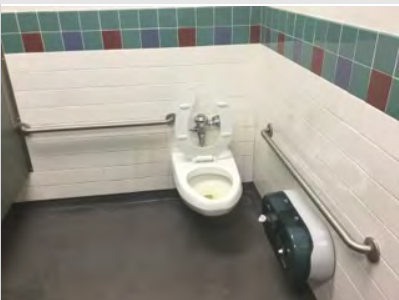
Toilet Rooms for Children												
118	Boys' Toilet Room Near Gym	G	G02 / G11	Toilet Compartment	Accessible Compartment

Non-compliant toilet paper dispenser	-	Replace toilet paper dispenser as it does not allow continuous paper flow.	1	353	\$353

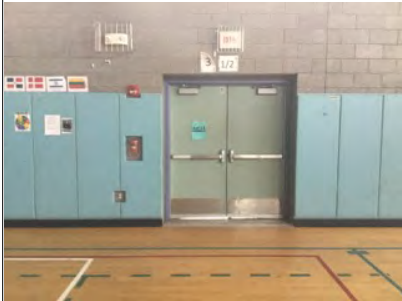
Illuminated exit sign with International Symbol of Acc. not provided Tactile exit sign not provided	-	At accessible exits provide an illuminated sign with the International Symbol of Accessibility (ISA). Provide a tactile exit sign with raised characters and braille at exit doors. Mount signs between 48"- 60" above finished floor located on the latch side of the door.	2	116	\$232
Access to Goods and Services												
120	After School Program	G	G04A	Interior Access Route	N/A

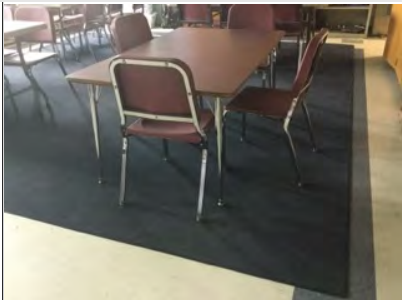
Surface not stable, firm, and slip-resistant	-	Securely attach mat.	1	Labor	\$0
Additional Access												
121	After School Program	G	G04A	Sink	Classroom

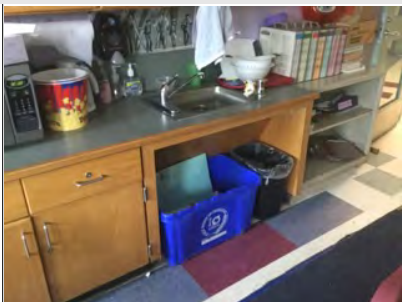
Toe and knee clearances not provided	-	Ensure there is knee clearance positioned for a forward approach by relocating the recycling bin and trash bin. 18" deep at the sink is not entirely compliant, but usable.	1	Labor	\$0

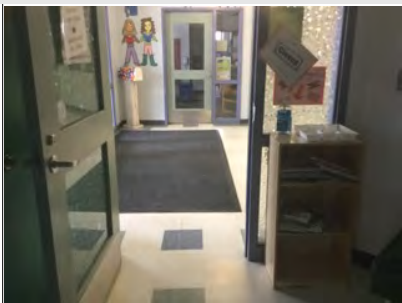
Access to Goods and Services												
122	Health Center	G	G05A	Doors, Doorways, & Gates	N/A

Maneuvering clearance(s) not provided	-	Relocate bookshelf to ensure 18" clear on the latch pull side of the door.	1	Labor	\$0

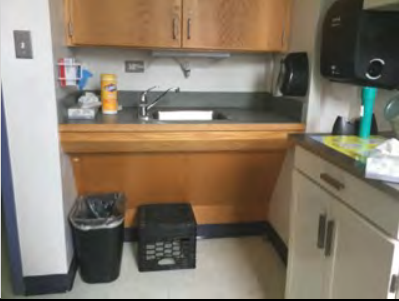
Toe and knee clearances not provided	18" deep	Ensure there is knee clearance positioned for a forward approach by relocating the recycling bin and trash bin. 18" deep at the sink is not entirely compliant, but usable.	1	Labor	\$0
Best Practice												
124	Health Center	G	G05A

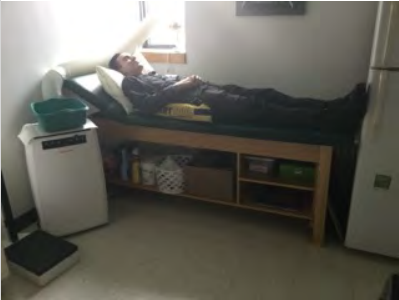
-	Best Practice: Provide an adjustable height exam table.	1	-	\$0
Toilet & Bathing Rooms												
125	Health Center Toilet Room	G	G05A	Shower Compartment	N/A

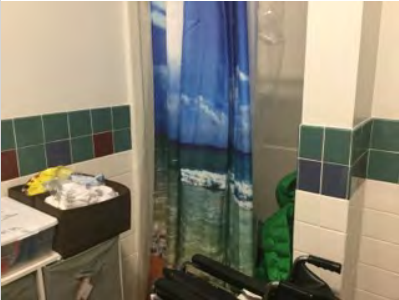
Transfer type shower threshold > 1/2" Accessible shower not provided	- -	Provide at least one accessible shower. Ensure the threshold is 1/2" high max. Note: On March 22, 2018; The Massachusetts Office of Public Safety and Inspections Architectural Access Board granted relief until Feb. 2021 on the condition that status reports are provided to the board on January 1,2019 and every six months thereafter.	1	3036	\$3036

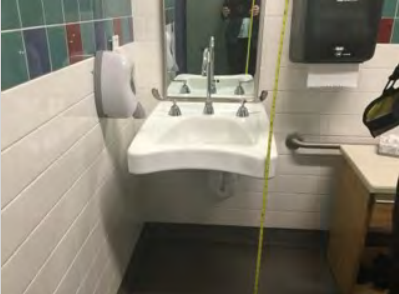
126	Health Center Toilet Room	G	G05A	Dispensers	Paper Towel Dispenser

Dispenser acts as a protruding object	-	Relocate paper towel dispenser so that it does not obstruct grab bar use. Per 521 CMR, no dispensers can be mounted above the grab bar.	1	353	\$353

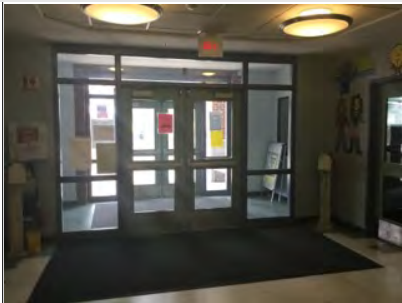
Illuminated exit sign with International Symbol of Acc. not provided Tactile exit sign not provided	-	At accessible exits provide an illuminated sign with the International Symbol of Accessibility (ISA). Provide a tactile exit sign with raised characters and braille at exit doors. Mount signs between 48"- 60" above finished floor located on the latch side of the door.	2	116	\$232

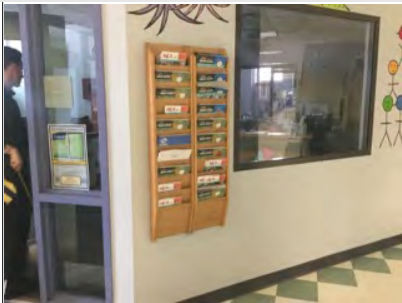
Access to Goods and Services												
129	Near Main Office	G	G05A	Operable Parts	Other

Reach < 15" or > 48"(forward/side approach)	66.6"	Reposition wall rack so that books/magazines are between 15"- 48" above finished floor.	1	128	\$128
Access to Goods and Services												
130	Main Office	G	G06A	Signage	Designation

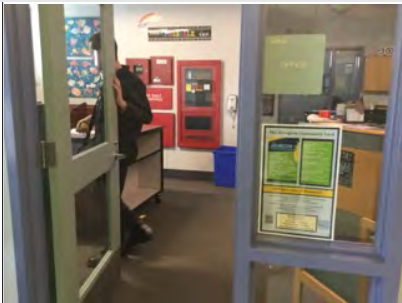
Non glare finish and contrast not provided	-	Provide signs with a non-glare finish with characters that have a high contrast to the background.	1	116	\$116

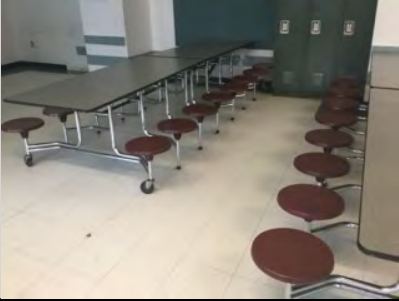
At least one or 5% accessible tables not provided Knee or toe clearance not provided	- -	Based on a count of 48 seats, provide at least 3 accessible spaces with 24" min. high 30" min. wide knee and toe clearance. (Cost estimate for one (1) new dining table.)	1	550	\$550
Access to Goods and Services												
132	Boys' Toilet Room	G	G12 / G31	Signage	Designation

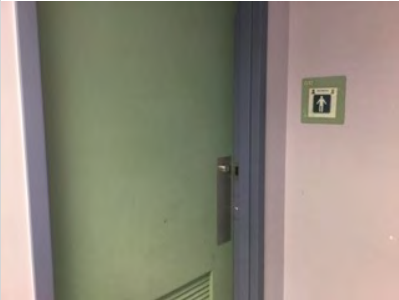
Raised characters not provided Braille not provided International Symbol of Acc. not compliant	- -	Provide text with raised characters duplicated in braille. Replace sign with a sign containing the International Symbol of Accessibility.	1	116	\$116
Toilet Rooms for Children												
133	Boys' Toilet Room	G	G12 / G31	Toilet Compartment	Accessible Compartment

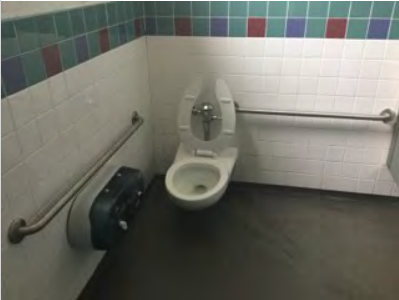
Non-compliant toilet paper dispenser	-	Replace toilet paper dispenser as it does not allow continuous paper flow. Note: Regarding accessible compartment door clearance, on March 22, 2018; The Massachusetts Office of Public Safety and Inspections Architectural Access Board granted relief.	1	353	\$353

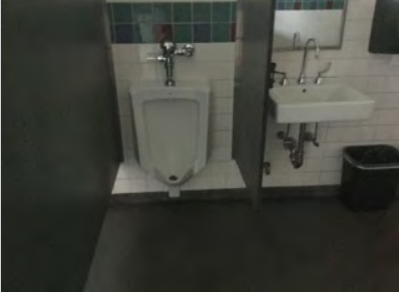
134	Boys' Toilet Room	G	G12 / G31	Urinal	N/A

Urinal has < 30" clear width	24"	Remove partition to provide a 30" min. by 48" min. clear floor space positioned for a forward approach.	2	128	\$256

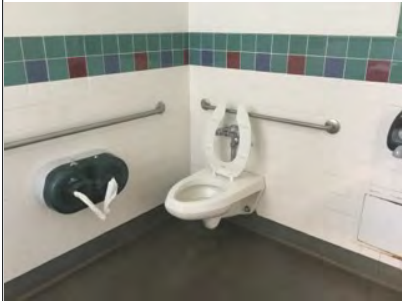
Rear grab bar > 42" long Toilet paper dispenser is not compliant	36" -	Provide a rear wall grab bar that is 42" long min. and extends from the toilet 12" min. on one side and 24" min. on the other side (open side). Replace toilet paper dispenser as it does not allow continuous paper flow.	1	802	\$802
Access to Goods and Services												
136	Women's Toilet Room	G	G19 / G41	Doors, Doorways, & Gates	Toilet Room

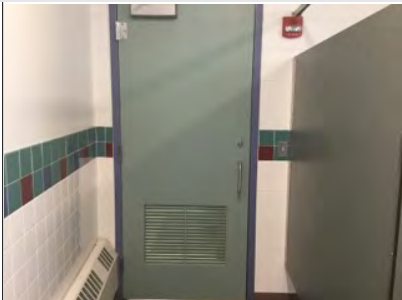
Maneuvering clearance(s) not provided	10.5"	Provide an automatic door opener.	1	1530	\$1530
Toilet & Bathing Rooms												
137	Women's Toilet Room	G	G19 / G41	Toilet Compartment	Accessible Compartment

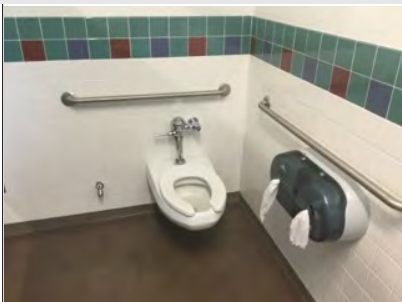
Door has malfunctioning self-closing hinge Rear grab bar < 42" long Non-compliant toilet paper dispenser	- 36" -	Repair hinge. Provide a rear wall grab bar that is 42" long min. and extends from the toilet 12" min. on one side and 24" min. on the other side (open side). Replace toilet paper dispenser as it does not allow continuous paper flow.	1	Labor 802	\$802

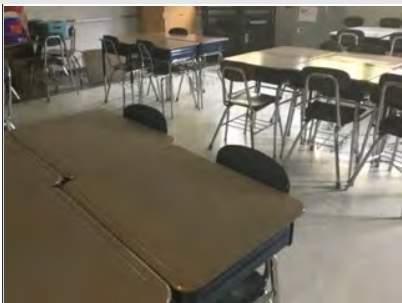
Access to Goods and Services												
138	Classroom	G	G20A	Dining or Work Surfaces	Work Surface

At least one or 5% accessible tables not provided Knee or toe clearance not provided	- 22" wide	Provide at least 1 work surface with 24" min. high, 30" min. wide knee and toe clearance.	1	350	\$350

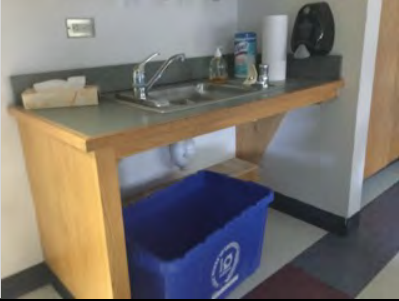
Toe and knee clearances not provided	18" deep	Ensure there is knee clearance positioned for a forward approach by relocating the recycling bin and trash bin. 18" deep at the sink is not entirely compliant, but usable.	1	Labor	\$0
Access to Goods and Services												
140	Classroom	G	G20A G32	Interior Access Route	N/A

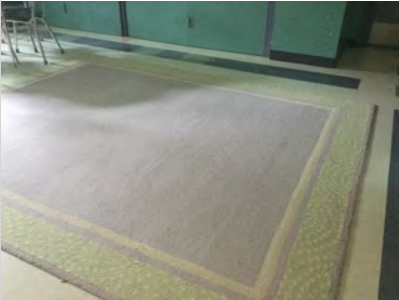
Surface not stable, firm, and slip-resistant	-	Securely attach mats.	2	Labor	\$0
Access to Goods and Services												
141	Music Room	G	G27B / G28	Doors, Doorways, & Gates	Classroom

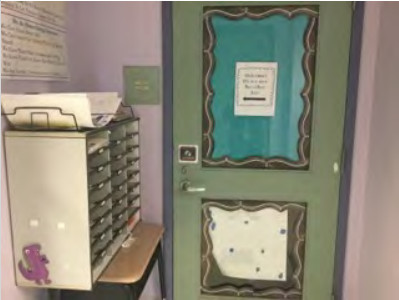
Maneuvering clearance(s) not provided	-	Relocate table and shelf to ensure 18" clear on the latch pull side of the door. Ensure there is clear floor space at the sign alongside the door.	1	Labor	\$0
142	Music Room	G	G27B / G28	Doors, Doorways, & Gates	Classroom

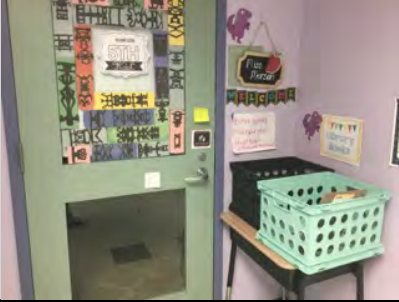
Maneuvering clearance(s) not provided	-	Relocate table and boxes to ensure 18" clear on the latch pull side of the door.	1	Labor	\$0

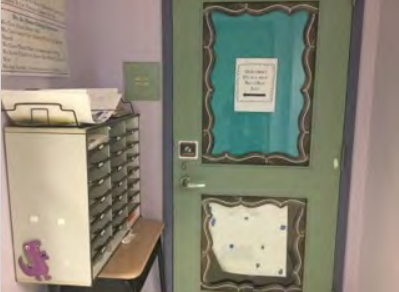
143	Music Room	G	G27B / G28	Signage	Designation

Non glare finish and contrast not provided	-	Provide signs with a non-glare finish with characters that have a high contrast to the background.	1	116	\$116

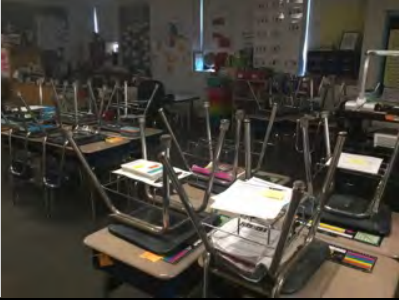
At least one or 5% accessible tables not provided	22" wide	Provide at least 1 work surface with 24" min. high, 30" min. wide knee and toe clearance.	1	350	\$350
Access to Goods and Services												
145	Classroom	G	G32	Doors, Doorways, & Gates	N/A

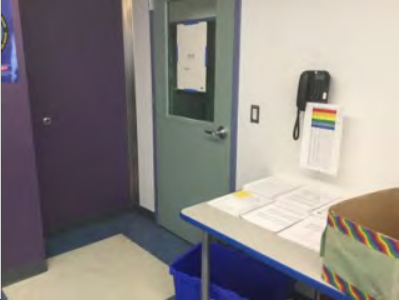
Maneuvering clearance(s) not provided	13.75"	Relocate the table so that there is 18" clear on the latch pull side of the door.	1	Labor	\$0
Access to Goods and Services												
146	Exit 9	G	G47A	Means of Egress	N/A

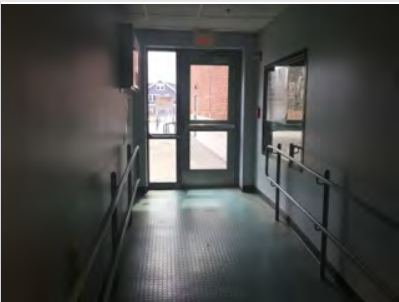
Illuminated exit sign with International Symbol of Acc. not provided Tactile exit sign not provided	-	At accessible exits provide an illuminated sign with the International Symbol of Accessibility (ISA). Provide a tactile exit sign with raised characters and braille at exit doors. Mount signs between 48"- 60" above finished floor located on the latch side of the door.	2	116	\$232

Accessibility issues include a lack of tactile exit signs at all exits. At exits which are accessible, there is a lack of the required International Symbol of Accessibility (ISA) on the illuminated exit sign, and non-accessible exits lack directional signage to accessible exits. Additionally, exits throughout the building have thresholds that are significantly higher than allowable. IHCD recommends addressing the excessive threshold at exits 3, 9 and 13.

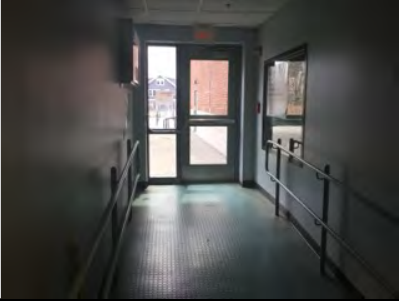
147	Exit 9	G	G47A	Ramps	Interior

Running slope >1:12 (8.33%)	8.9%	Provide an automatic door opener at door. Note: On March 22, 2018; The Massachusetts Office of Public Safety and Inspections Architectural Access Board granted relief to the door at the top of the ramp on the condition that an automatic door opener is installed.	1	1530	\$1530
Best Practice												
148	Corridor Near G27A	G	G48

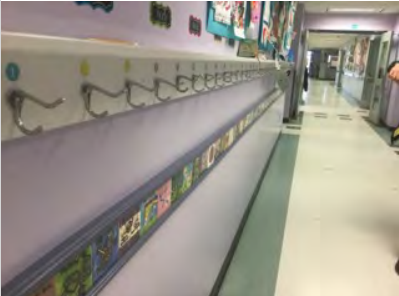
49"	Best Practice: Provide at least one hook is 36" maximum above the finished floor.	1	-	\$0

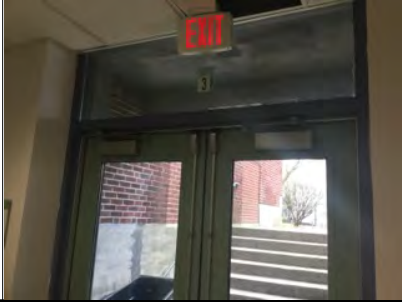
Tactile exit sign not provided Directional sign to accessible emergency exit not provided	-	Provide a directional sign indicating the location of the nearest emergency exit. Provide a tactile exit sign with raised characters and braille at exit doors. Mount signs between 48"- 60" above finished floor located on the latch side of the door.	2	116	\$232
Access to Goods and Services												
150	Exit 7 Near G34	G	G48	Means of Egress	N/A

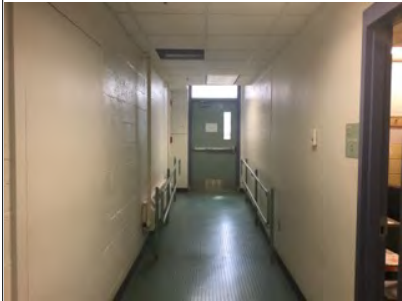
Illuminated exit sign with International Symbol of Acc. not provided Tactile exit sign not provided	- -	At accessible exits provide an illuminated sign with the International Symbol of Accessibility (ISA). Provide a tactile exit sign with raised characters and braille at exit doors. Mount signs between 48"- 60" above finished floor located on the latch side of the door.	2	116	\$232

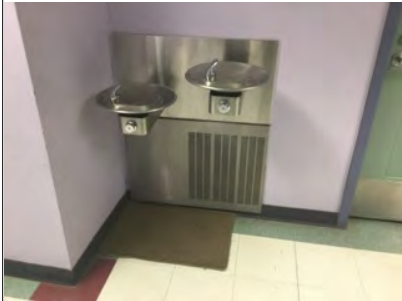
Additional Access												
151	Near G27A	G	G48	Drinking Fountains	Hi-Lo

Standing height fountain does not have cane protection	-	Provide a cane-detectable barrier skirt under the high unit. Note: On March 22, 2018; The Massachusetts Office of Public Safety and Inspections Architectural Access Board granted relief until Feb. 2021 on the condition that status reports are provided to the board on January 1, 2019 and every six months thereafter.	1	445	\$445
Access to Goods and Services												
152	To Exit 2	G	GS2	Means of Egress	N/A

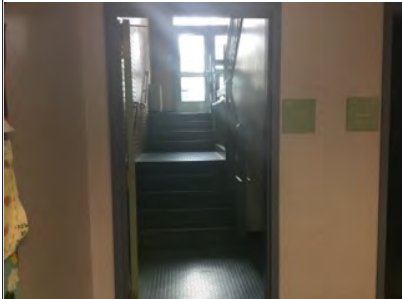
Directional sign to accessible emergency exit not provided	-	Provide a directional sign indicating the location of the nearest emergency exit.	1	116	\$116

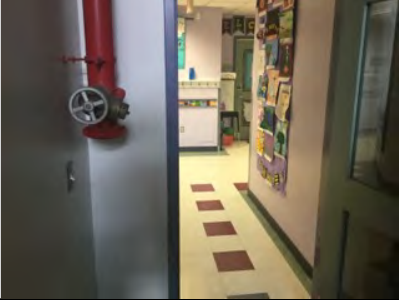
ID	Location	Floor	Room	Element	Type	Photo	Issues	Current Measure	Recommendations	Quantity	Price	Cost Estimation
153	To Exit 2	G	GS2	Interior Access Route	N/A

Obstructed by protruding objects	9"	Provide a cane-detectable barrier at the valve.	1	153	\$153
Approach and Entrance												
154	Exit 7	G	Near G34	Emergency Exit	N/A

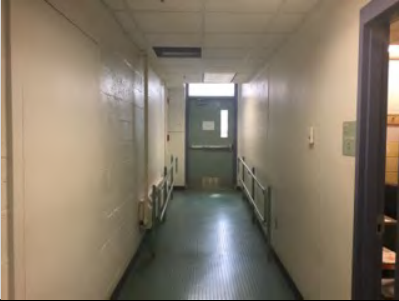
Maneuvering clearance(s) not provided	-	Provide an automatic door opener.	1	1530	\$1530

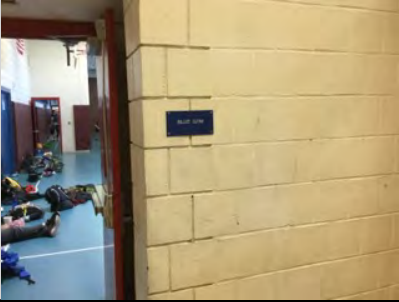
ID	Location	Floor	Room	Element	Type	Photo	Issues	Current Measure	Recommendations	Quantity	Price	Cost Estimation
Access to Goods and Services												
1	Blue Gym	1		Signage	Designation

Sign not located on the latch side of the door	-	Locate sign at permanent rooms alongside the door on the latch side.	1	Labor	\$0
Access to Goods and Services												
2	Boys' Locker Room	1		Locker Room	Men's

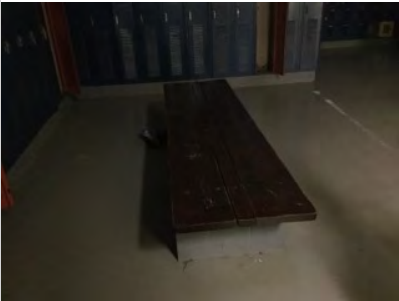
Back support not provided at bench Bench < 20" or > 24" deep	- 25"	Provide at least one bench that is 20"- 24" with back support and room on the side to transfer.	1	100	\$100
Access to Goods and Services												
3	Boys' Locker Room to Blue Gym	1		Doors, Doorways, & Gates	Circulation

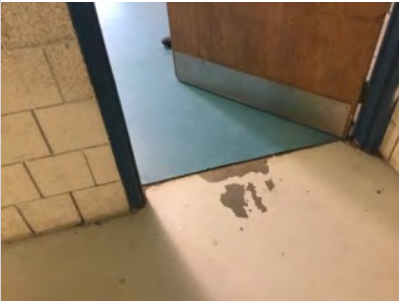
Threshold not beveled	-	Bevel threshold.	1	75	\$75
Toilet & Bathing Rooms												
4	Boys' Toilet Room in Locker Room	1		Toilet Compartment	Accessible Compartment

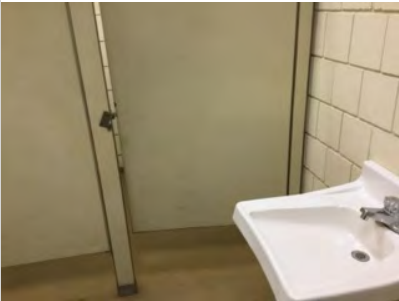
Door has inadequate maneuvering clearance	20"	Remove lavatory to provide adequate maneuvering clearance or redo toilet room. (Cost estimate based on removal of lavatory.)	1	500	\$500

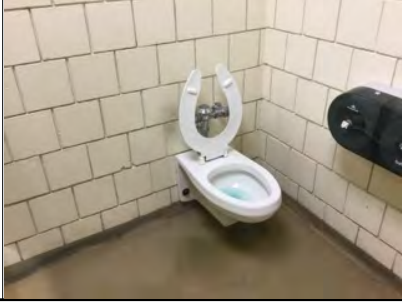
ID	Location	Floor	Room	Element	Type	Photo	Issues	Current Measure	Recommendations	Quantity	Price	Cost Estimation
5	Boys' Toilet Room in Locker Room	1		Toilet Compartment	Accessible Compartment

Door has malfunctioning self-closing hinge Grab bars not provided Non-compliant toilet paper dispenser	- - -	Repair hinge. Provide one grab bar on the side wall of the water closet and one on the rear wall. Replace dispenser that does not allow continuous paper flow. Mount toilet paper so that it is 15" min. high, located under the grab bar, and between 7" and 9" from the front rim of the toilet.	1	Labor 802	\$802
Best Practice												
6	Boys' Toilet Room in Locker Room	1

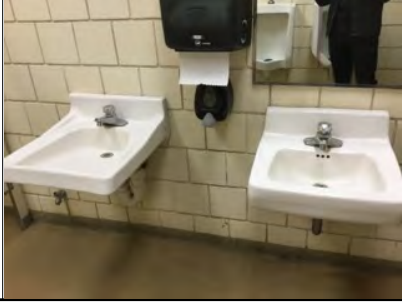
Best Practice: Recommend providing an additional mirror at the accessible lavatory for parity of features at accessible and inaccessible lavatory.	1	-	\$0
Toilet & Bathing Rooms												
7	Boys' Toilet Room Near Cafeteria	1		Urinal	N/A

- At the boys’ toilet room in the locker room, IHCD recommends providing an additional mirror at the accessible lavatory for parity of features at accessible and inaccessible lavatory.

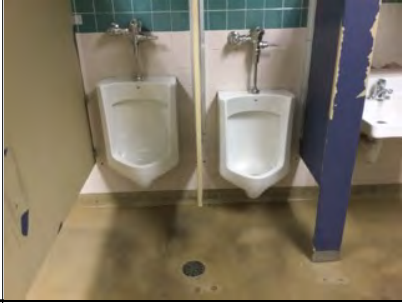
Urinal recessed > 24" has > 36" clear width	30"	If urinal is recessed greater than 24" ensure there is a clear width of 36". Reconfigure partition at accessible urinal.	1	256	\$256

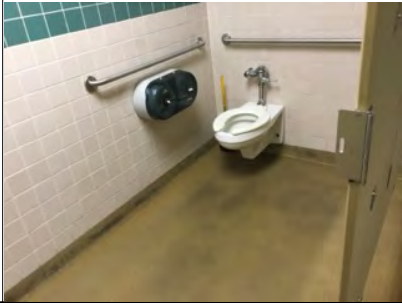
8	Boys' Toilet Room Near Cafeteria	1		Toilet Compartment	Accessible Compartment

Door has malfunctioning self-closing hinge Non-compliant toilet paper dispenser Centerline < or > 18" (MAAB)	- - 19"	Repair hinge. Relocate toilet paper so that it is 15" min. high, located under the grab bar, and between 7" and 9" from the front of the toilet. Replace dispenser if it does not allow continuous paper flow. Toilet centerline is not entirely compliant, but is usable.	1	Labor 353	\$353
9	Boys' Toilet Room Near Cafeteria	1		Toilet Compartment	Accessible Compartment

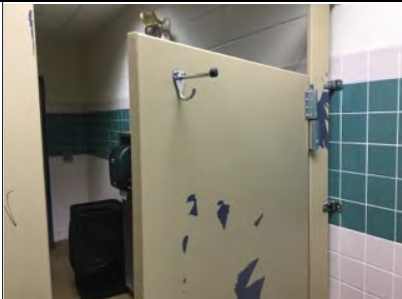
Coat hook > 48"	65"	Lower coat hook so that it is no higher than 48".	1	75	\$75

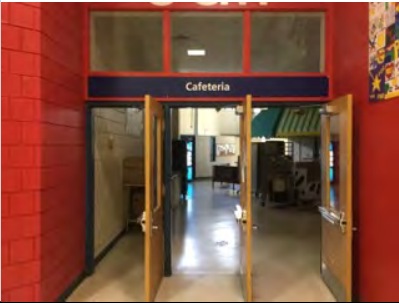
ID	Location	Floor	Room	Element	Type	Photo	Issues	Current Measure	Recommendations	Quantity	Price	Cost Estimation
Access to Goods and Services												
10	Cafeteria	1		Signage	Designation

Raised characters not provided Braille not provided Sign not located on the latch side of the door	- - -	Provide text with raised characters duplicated in braille. Locate sign at permanent rooms alongside the door on the latch side.	1	116	\$116
11	Cafeteria	1		Ramps	Interior

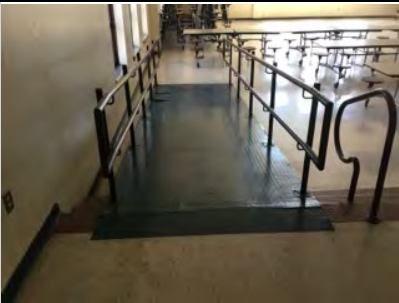
Edge protection < 4" high	-	Provide edge protection on both sides that prevents the passage of a 4" diameter sphere, where any portion of the sphere is within 4" of the finished floor or ground surface. In additions, edge curbs must be a min. of 2" high per 521 CMR.	2	1260	\$2520
12	Cafeteria	1		Ramps	Interior

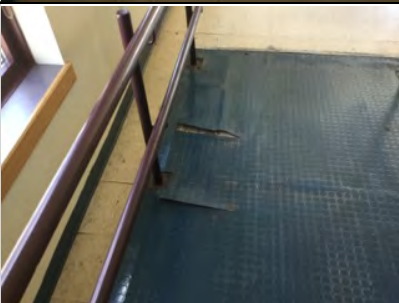
Not maintained in operable working condition	-	Ensure the ramp surface is maintained in operable working condition.	1	Labor	\$0

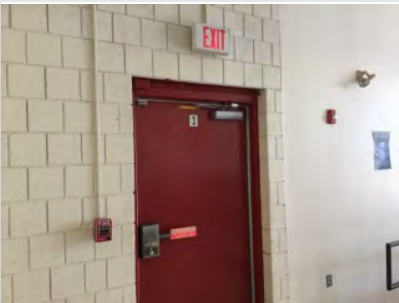
Approach and Entrance												
13	Exit 3	1		Emergency Exit	N/A

International Symbol of Acc. not provided Tactile exit sign not provided	- -	Provide a tactile exit sign with raised characters and braille at exit doors. Mount the sign between 48" - 60" above the finished floor on the latch side of the door. Provide the International Symbol of Accessibility on the illuminated exit sign above exit doors after the exterior step is made accessible. See other record on resolving the threshold at the door.	2	116	\$232
Approach and Entrance												
14	Exit 7 Near Blue Gym	1		Emergency Exit	N/A

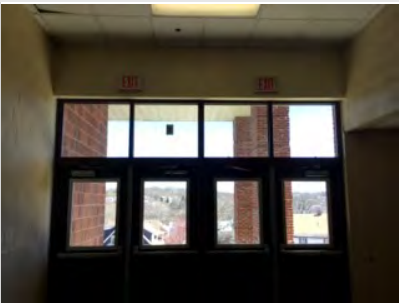
International Symbol of Acc. not provided Tactile exit sign not provided	- -	Provide the International Symbol of Accessibility on the illuminated exit sign above exit doors. Provide a tactile exit sign with raised characters and braille at exit doors. Mount the sign between 48" - 60" above the finished floor on the latch side of the door.	2	116	\$232

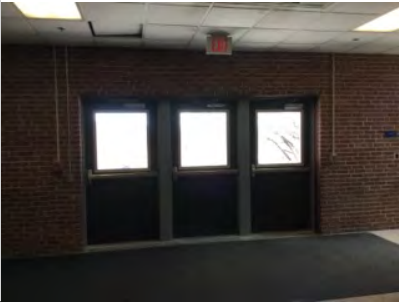
ID	Location	Floor	Room	Element	Type	Photo	Issues	Current Measure	Recommendations	Quantity	Price	Cost Estimation
Approach and Entrance												
15	Exit 9 Near Locker Rooms	1		Emergency Exit	N/A

International Symbol of Acc. not provided Tactile exit sign not provided	- -	Provide a tactile exit sign with raised characters and braille at exit doors. Mount the sign between 48" - 60" above the finished floor on the latch side of the door. After the threshold to the door is renovated, provide the International Symbol of Accessibility on the illuminated exit sign above exit doors. (See other record on Exit 9 for information on the threshold.)	2	116	\$232
16	Exit 9 Near Locker Rooms	1		Emergency Exit	N/A

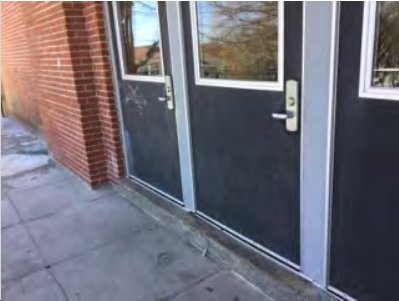
Threshold > 1/2" high	9"	Alter threshold to be 1/2" high max. Build a 6' by 6' concrete platform at the door. Provide a 15' long concrete accessible route to the plaza. (Cost estimate for a 6' x 6' platform at the exit door and a sloped concrete accessible route to the walkway.)	1	1840	\$1840

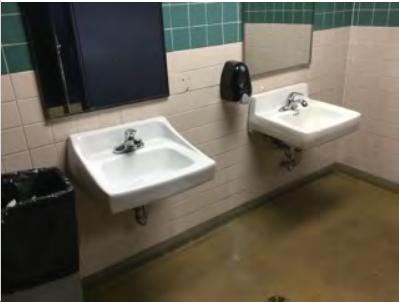
Toilet & Bathing Rooms												
17	Girl's Toilet Room Near Cafeteria	1		Lavatory	N/A

Plumbing underneath is exposed	-	Insulate or otherwise configure pipes to prevent contact, for at least one lavatory.	1	46	\$46
Toilet & Bathing Rooms												
18	Girls' Toilet Room Near Cafeteria	1		Toilet Compartment	Accessible Compartment

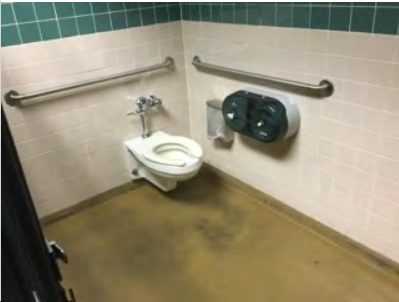
Door has malfunctioning self-closing hinge Non-compliant toilet paper dispenser	- -	Repair hinge. Replace dispenser that does not allow continuous paper flow.	1	Labor 353	\$353

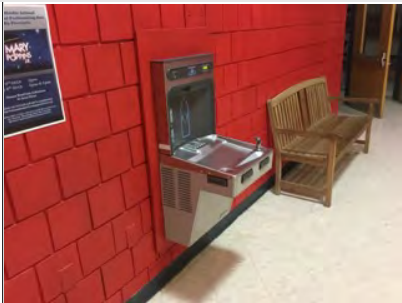
No drinking fountain provided for standing users	-	Provide an additional drinking fountain for standing users.	1	2014	\$2014
Access to Goods and Services												
21	Nurse's Office	1		Signage	Designation

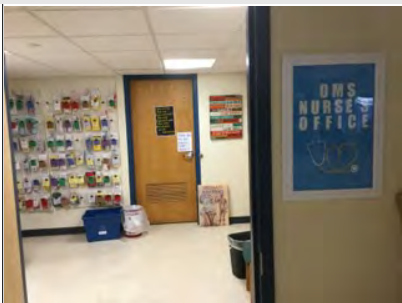
Raised characters not provided Braille not provided Non glare finish and contrast not provided	- - -	Provide text with raised characters duplicated in braille. Provide signs with a non-glare finish with characters that have a high contrast to the background.	1	116	\$116

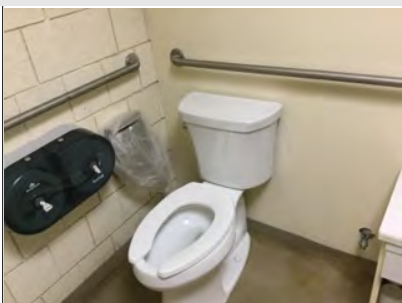
Toilet & Bathing Rooms												
22	Nurse's Office Toilet Room	1		Single-User Toilet	N/A

Flush control not on open side Clearance at toilet < 60" clear width Toilet paper dispenser is not compliant	- - -	Relocate the flush control to the open side. Remove the table that blocks the clear floor space required at the toilet. Replace dispenser that does not allow continuous paper flow.	1	540	\$540

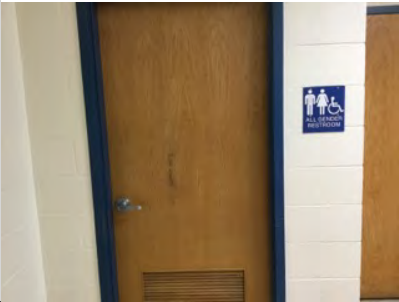
ID	Location	Floor	Room	Element	Type	Photo	Issues	Current Measure	Recommendations	Quantity	Price	Cost Estimation
Access to Goods and Services												
23	Single-User Toilet Room Near Cafeteria	1		Signage	Designation

Sign not located on the latch side of the door	-	Locate sign at permanent rooms alongside the door on the latch side. Where there is no wall space at the latch side of the door, signs should be located on the nearest adjacent wall.	1	Labor	\$0
Toilet & Bathing Rooms												
24	Single-User Toilet Room Near Cafeteria	1		Lavatory	N/A

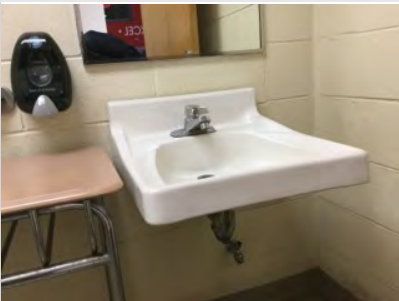
Plumbing underneath is exposed	-	Insulate or otherwise configure pipes to prevent contact at lavatory.	1	46	\$46
25	Single-User Toilet Room Near Cafeteria	1		Single-User Toilet	N/A

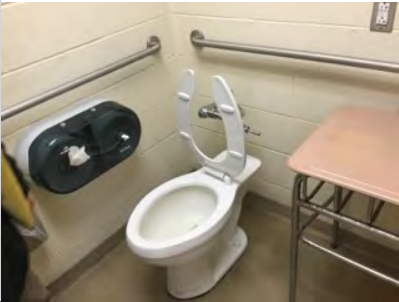
Centerline < or > 18" (MAAB) Clearance at toilet < 60" clear width Toilet paper dispenser is not compliant	19" - -	Relocate toilet so that the centerline is 18" from the side wall. Remove the table that blocks the clear floor space required at the toilet. Replace dispenser that does not allow continuous paper flow.	1	1767	\$1767

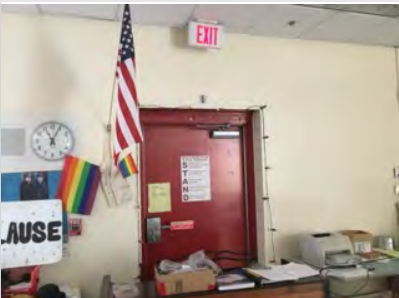
Approach and Entrance												
26	Exit 6 in Music Room	1	101	Emergency Exit	N/A

International Symbol of Acc. not provided Tactile exit sign not provided Maneuvering clearance(s) not provided	- -	Provide the International Symbol of Accessibility on the illuminated exit sign above exit doors. Provide a tactile exit sign with raised characters and braille at exit doors. Mount the sign between 48" - 60" above the finished floor on the latch side of the door. Remove items blocking access to the exit door.	2	116	\$232

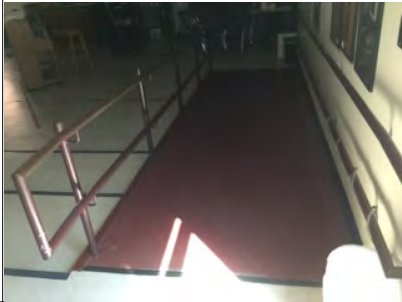
ID	Location	Floor	Room	Element	Type	Photo	Issues	Current Measure	Recommendations	Quantity	Price	Cost Estimation
Access to Goods and Services												
27	Music Room	1	101	Ramps	Interior

Handrails do not extend 12" past top & bottom Edge protection < 4" high	6" -	Alter handrails to extend horizontally above the landing for 12" min. beyond the top and bottom of ramp runs. Provide edge protection that prevents the passage of a 4" diameter sphere, where any portion of the sphere is within 4" of the finished floor or ground surface. In additions, edge curbs must be a min. of 2" high per 521 CMR.	1	1660	\$1660
28	Music Room	1	101	Dining or Work Surfaces	Work Surface

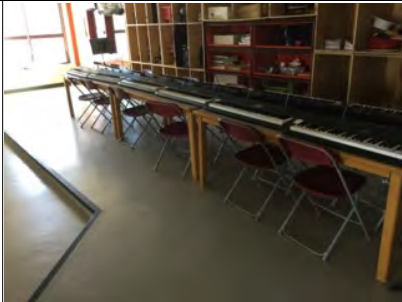
Knee or toe clearance not provided	25"	Relocate player pianos to an accessible height with knee and toe clearance.	1	Labor	\$0
Toilet & Bathing Rooms												
29	Boys' Toilet Room Near 207	2		Toilet Compartment	Accessible Compartment

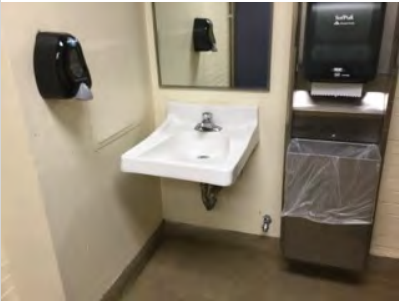
ID	Location	Floor	Room	Element	Type	Photo	Issues	Current Measure	Recommendations	Quantity	Price	Cost Estimation
Toilet & Bathing Rooms												
31	Boys' Toilet Room Near Technical Engineering Class	2		Lavatory	N/A

Plumbing underneath is exposed	-	Insulate or otherwise configure pipes to prevent contact at lavatory.	1	46	\$46
32	Boys' Toilet Room Near Technical Engineering Class	2		Urinal	N/A

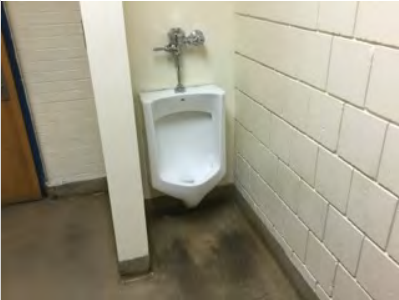
Urinal has < 30" clear width	26"	Remove the wing wall and replace with a privacy partition to ensure there is 30" clear minimum at the lavatory.	1	589	\$589
33	Boys' Toilet Room Near Technical Engineering Class	2		Toilet Compartment	Accessible Compartment

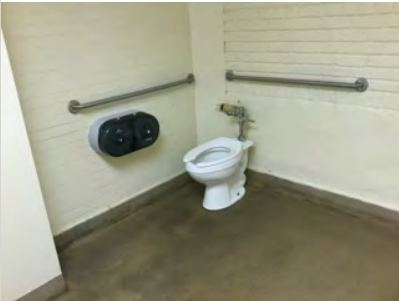
Door has malfunctioning self-closing hinge Non-compliant toilet paper dispenser	- -	Repair hinge. Replace dispenser that does not allow continuous paper flow.	1	Labor 353	\$353
Approach and Entrance												
34	Exit 11	2		Emergency Exit	N/A

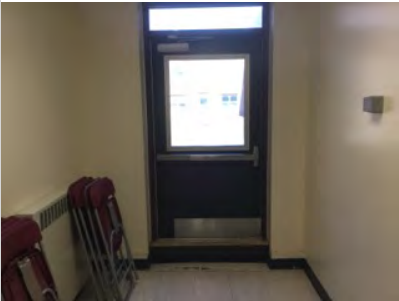
Emergency exit not on an accessible route Directional sign to accessible emergency exit not provided Tactile exit sign not provided	- - -	Provide a directional sign indicating the location of the nearest emergency exit. Provide a tactile exit sign with raised characters and braille at exit doors. Mount the sign between 48" - 60" above the finished floor on the latch side of the door.	2	116	\$232

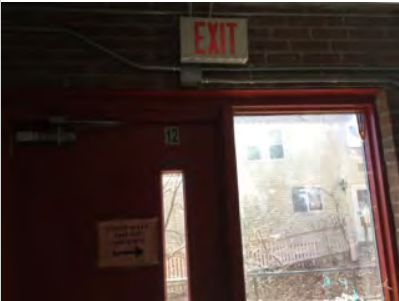
Approach and Entrance												
35	Exit 12, Near Upper Gym	2		Emergency Exit	N/A

Emergency exit not on an accessible route Directional sign to accessible emergency exit not provided Tactile exit sign not provided	- -	Provide a directional sign indicating the location of the nearest emergency exit. Provide a tactile exit sign with raised characters and braille at exit doors. Mount the sign between 48" - 60" above the finished floor on the latch side of the door.	2	116	\$232

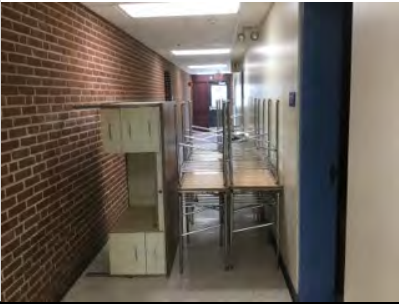
ID	Location	Floor	Room	Element	Type	Photo	Issues	Current Measure	Recommendations	Quantity	Price	Cost Estimation
Approach and Entrance												
36	Exit 13	2		Emergency Exit	N/A

Emergency exit not on an accessible route International Symbol of Acc. not provided Tactile exit sign not provided	<ul style="list-style-type: none">---	Relocate furniture from exit route. Provide a tactile exit sign with raised characters and braille at exit doors. Mount the sign between 48" - 60" above the finished floor on the latch side of the door. After the exit is made accessible, provide the International Symbol of Accessibility on the illuminated exit sign above exit doors. See other Exit 13 record on exterior step.	2	116	\$232
Approach and Entrance												
37	Exit 13 to Community Garden	2		Emergency Exit	N/A

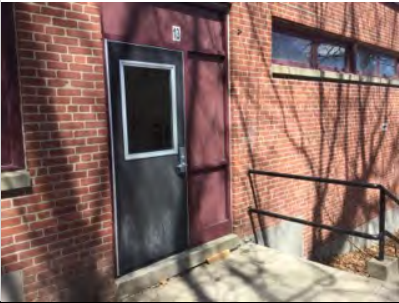
Threshold > 1/2" high	10"	Provide a concrete platform at exit door that connects to the exterior route leading to the community garden. (Cost estimate for a 6' x 6' platform at the exit door and a sloped concrete accessible route to the walkway to the community garden.)	1	1656	\$1656

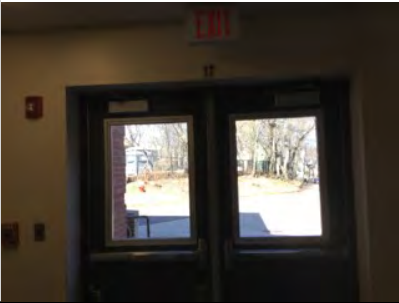
Approach and Entrance												
38	Exit 17 Near Technical Engineering Room	2		Emergency Exit	N/A

International Symbol of Acc. not provided Tactile exit sign not provided	<ul style="list-style-type: none">--	Provide the International Symbol of Accessibility on the illuminated exit sign above exit doors. Provide a tactile exit sign with raised characters and braille at exit doors. Mount the sign between 48" - 60" above the finished floor on the latch side of the door.	2	116	\$232
Toilet & Bathing Rooms												
39	Girls' Toilet Room Near 207	2		Toilet Compartment	Accessible Compartment

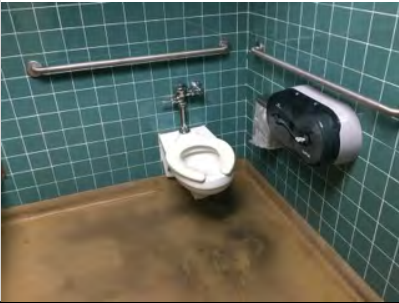
Non-compliant toilet paper dispenser	<ul style="list-style-type: none">-	Replace dispenser that does not allow continuous paper flow.	1	353	\$353

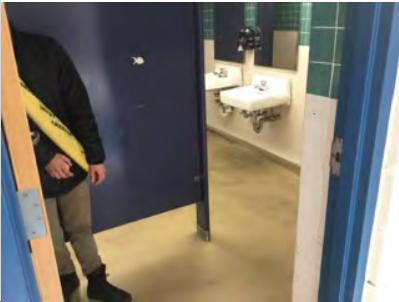
ID	Location	Floor	Room	Element	Type	Photo	Issues	Current Measure	Recommendations	Quantity	Price	Cost Estimation
Access to Goods and Services												
40	Girls' Toilet Room Near Media Center	2		Doors, Doorways, & Gates	Toilet Room

Maneuvering clearance(s) not provided	44"	Remove and relocate the partition to provide 54" min. clear depth at the pull side of the door. Ensure turning space is kept within the toilet room, when the partition is relocated.	1	706	\$706
Toilet & Bathing Rooms												
41	Girls' Toilet Room Near Media Center	2		Toilet Compartment	Accessible Compartment
